MATERIALS RESEARCH FOR THE CLEAN UTILIZATION OF COAL

QUARTERLY PROGRESS REPORT

October - December 1979

Center for Materials Science
National Bureau of Standards
Washington, D. C. 20234

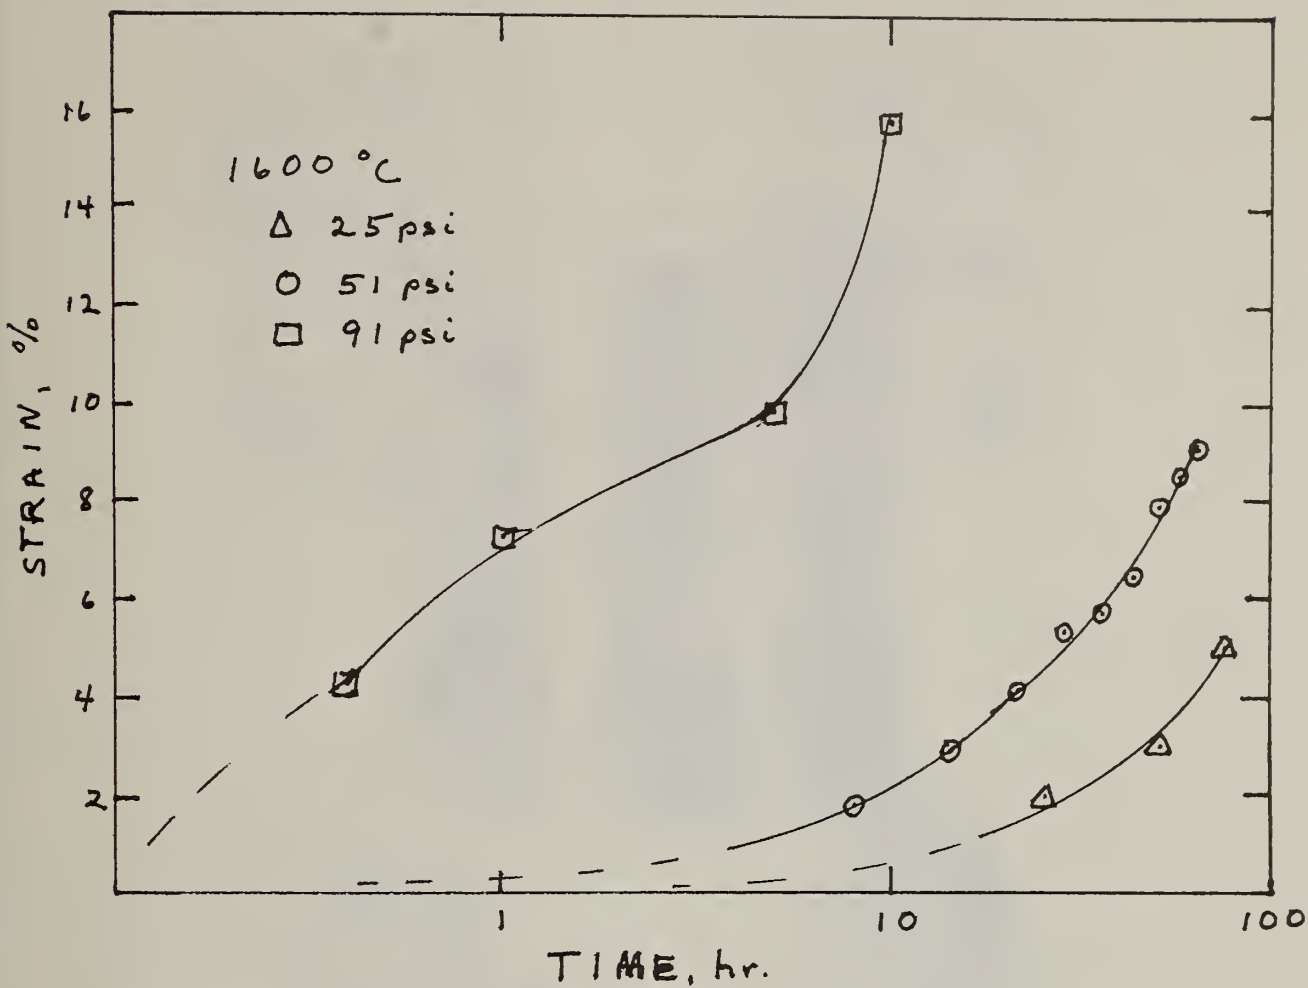
Fig. 1 Creep curves obtained under constant load conditions for the chrome spinel RFG refractory.

Results: The RFG refractory exhibited considerable creep at 1400 °C, 1500 °C and 1600 °C. Some of the data obtained from specimen measurements during loading are shown in Fig. 1. The plots show data obtained from the dialometric measurements and from dimensional measurements of the specimen. The specimen tested at 91 psi at 1600 °C failed catastrophically in approximately 2 hours. The actual deformation of the specimens is shown in the light micrographs shown in Fig. 2. In these pictures, the cracking and swelling are seen clearly.

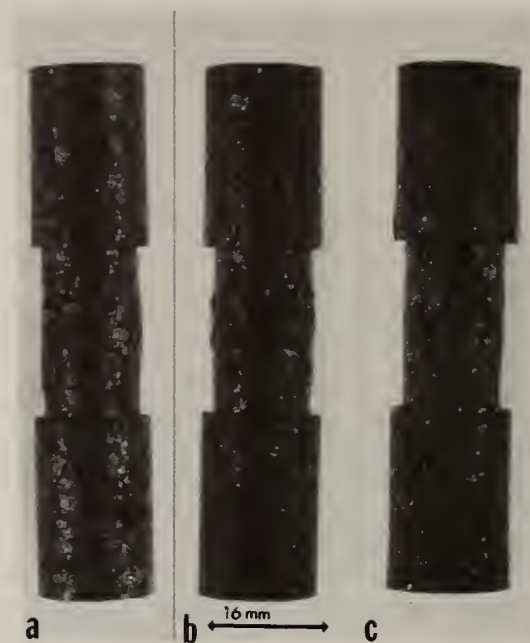
Fig. 2. Refractory RFG specimens from creep tests (a) 1400°C , 150 psi, 363 hr 7.5% deformation (b) 1500°C , 92 psi, 133 hr, 8.4% deformation (c) 1600°C , 51 psi, 63 hr 9.1% deformation.

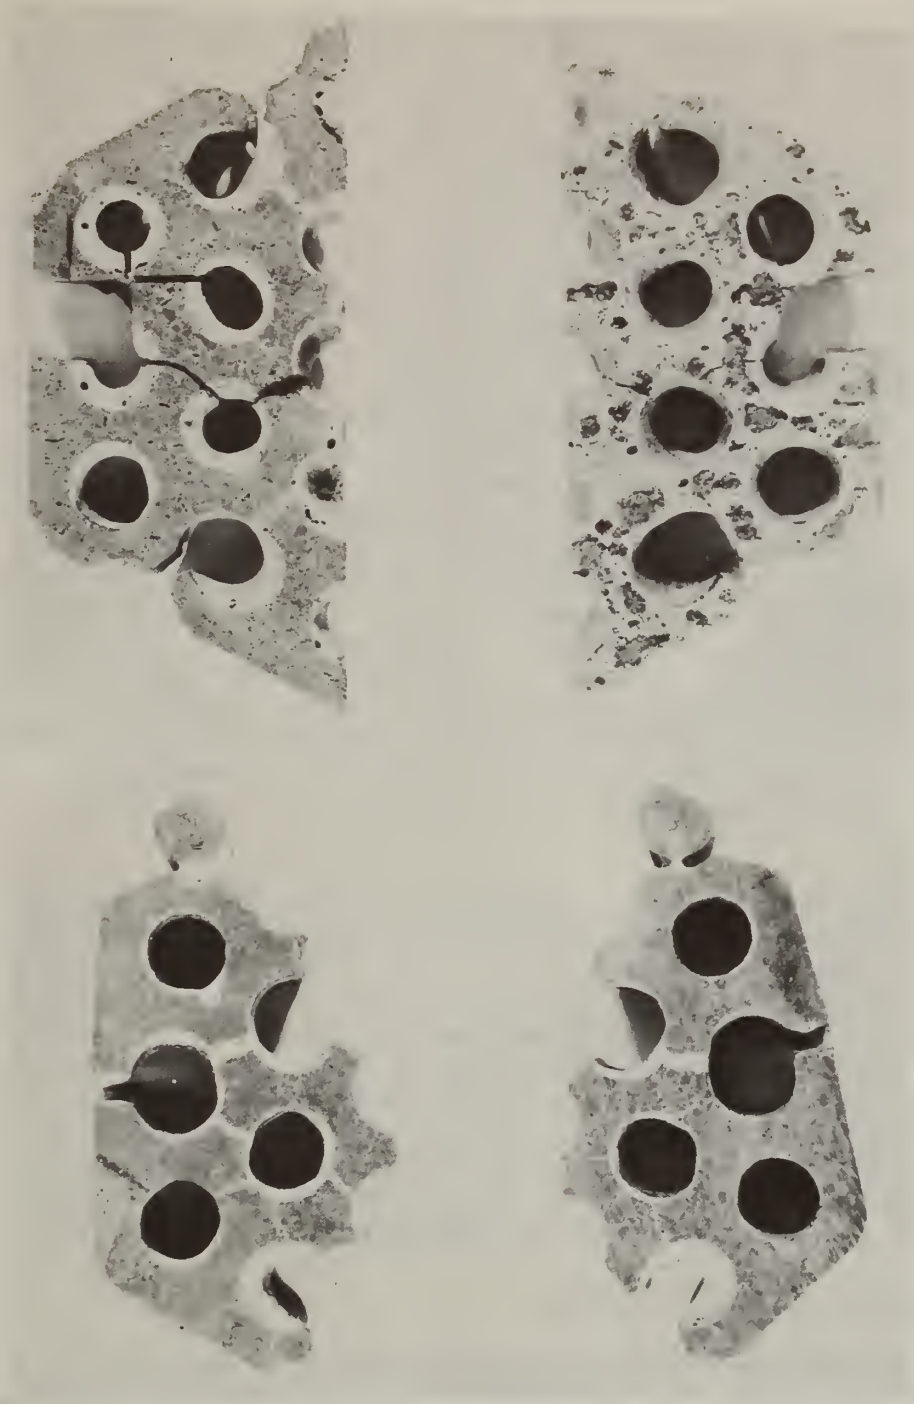
Fig. 3. Top and bottom surfaces of 1 in thick brick sections from Montana State test rig (a) brick 5-3 near top (b) brick 49-3, near bottom.

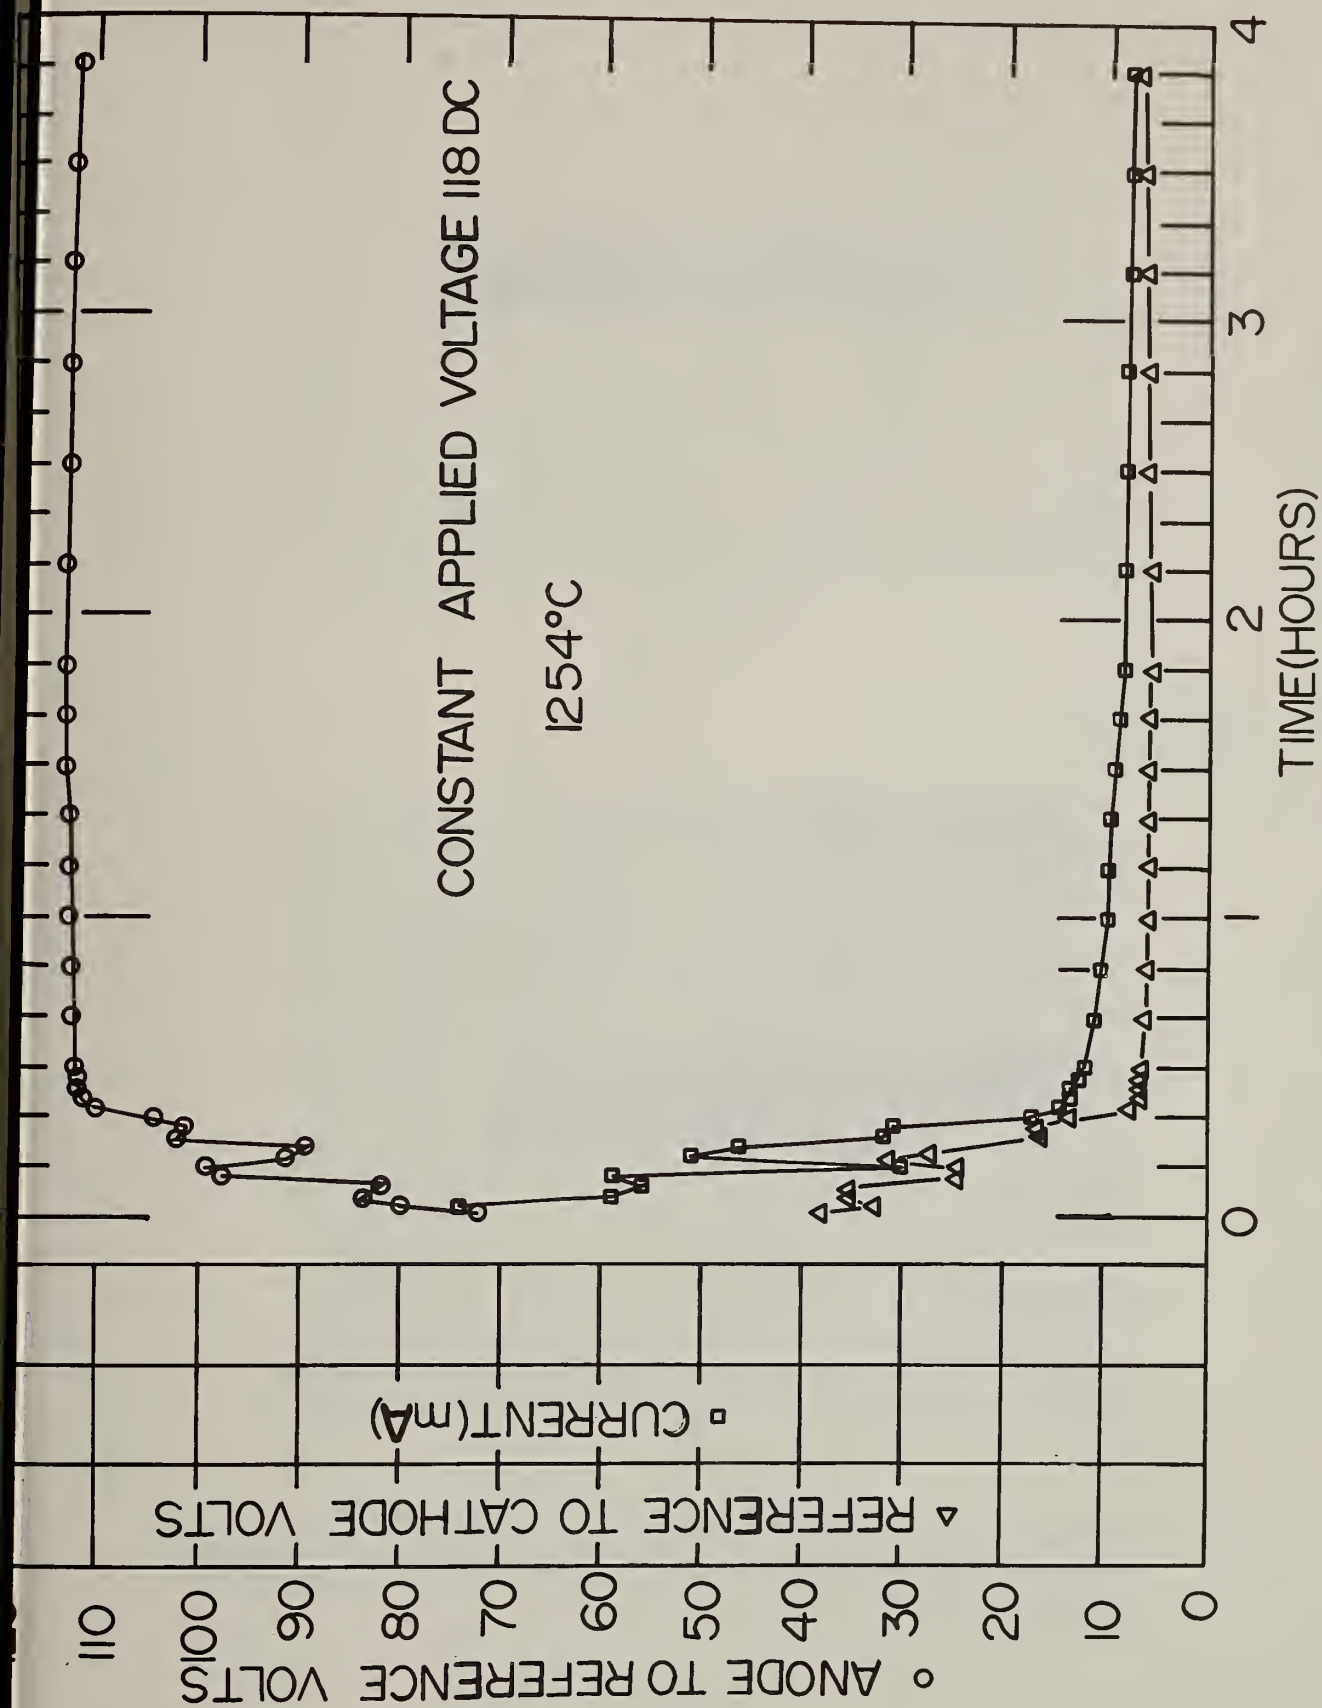
Figure 1. Time vs. voltage relationships in an electrochemical cell of $Y_{0.95}Ca_{0.05}CrO_3$ in a slag electrolyte with added K_2SO_4 .

In the last quarterly report, the results of a test on an electrochemical cell composed of $YCrO_3$ electrodes and Bow NH slag with 20% K_2SO_4 added were reported. This test was carried out at 1343 °C and resulted in considerable cathode reaction but with not much reaction at the anode. A new cell has been constructed and tested using the same materials (Bow NH slag with 20% K_2SO_4 electrolyte and $Y_{.95}Ca_{.05}CrO_3$ electrodes) but with a slightly different configuration. This cell contains 3 electrodes, two of which are active (anode and cathode at each end of the cell) and one which is passive (center of cell) which carries no current. This allows for direct measurement of the potential distribution along the length of the cell i.e. for potentials between

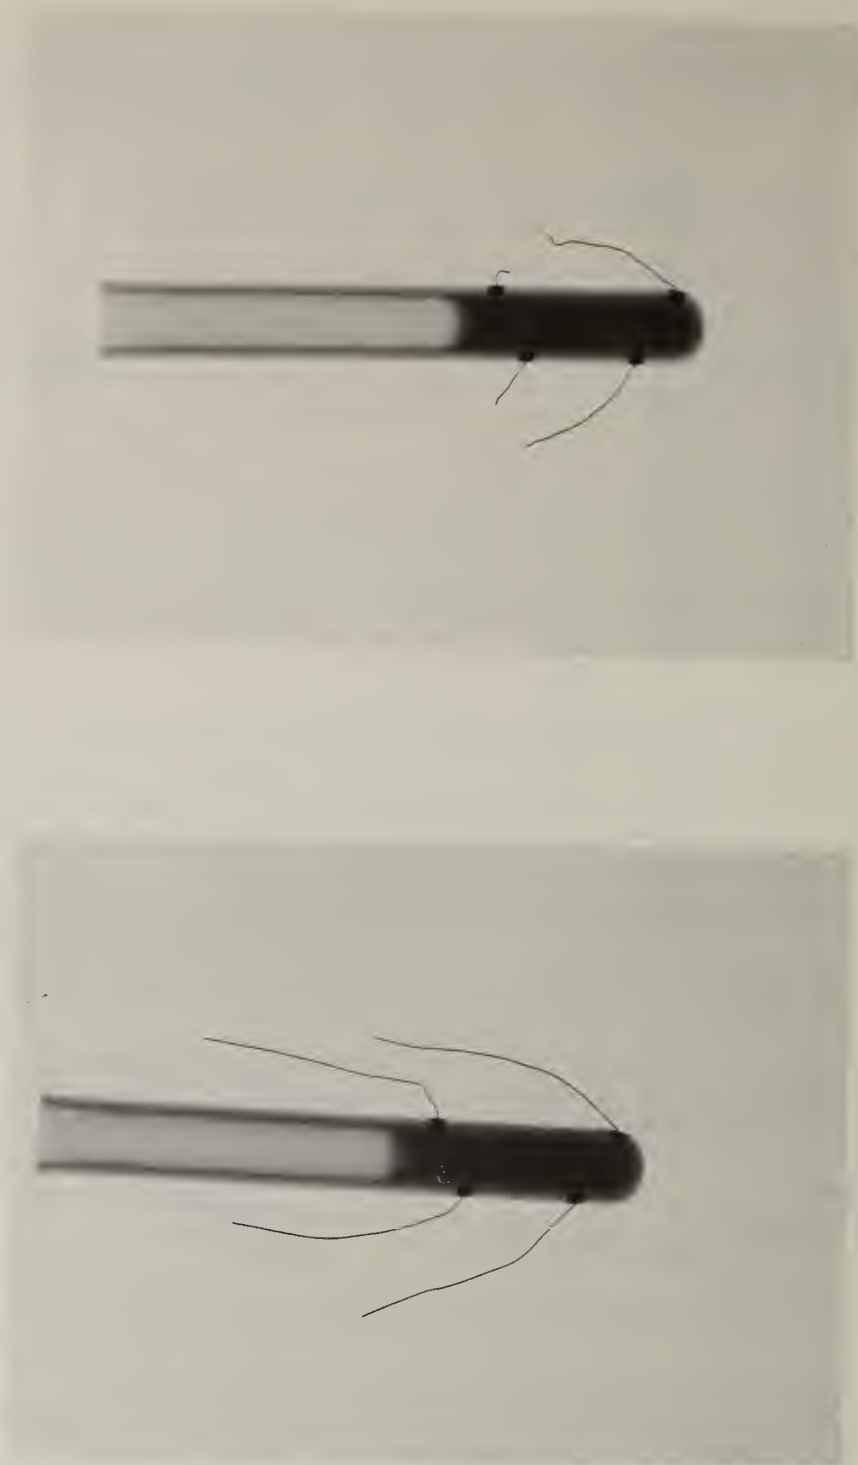
Figure 2. Radiograph of crucible showing slag fill and electrode configuration before (a) and after (b) electrical conductivity measurements.

The electrical conductivity of Bow NH slag with 20% K₂SO₄ added to the melt has been completed. Figure 2a and b show radiographs of the crucible containing the slag before and after the experiment. No observable physical change has taken place during the experiment. Figure 3 shows the conductivity data as a function of temperature. All data was taken at a partial pressure of oxygen of 2×10^{-6} atmospheres. The temperature from which the slag was furnace quenched to 900°C is indicated on the graph. The conductivity data at reduced oxygen pressure is not quite so quench temperature dependent as that data for the conductivity in air shown in the last quarterly report (July-Sept. 1979). The magnitude and the general trend is the same, however. There appears to be two

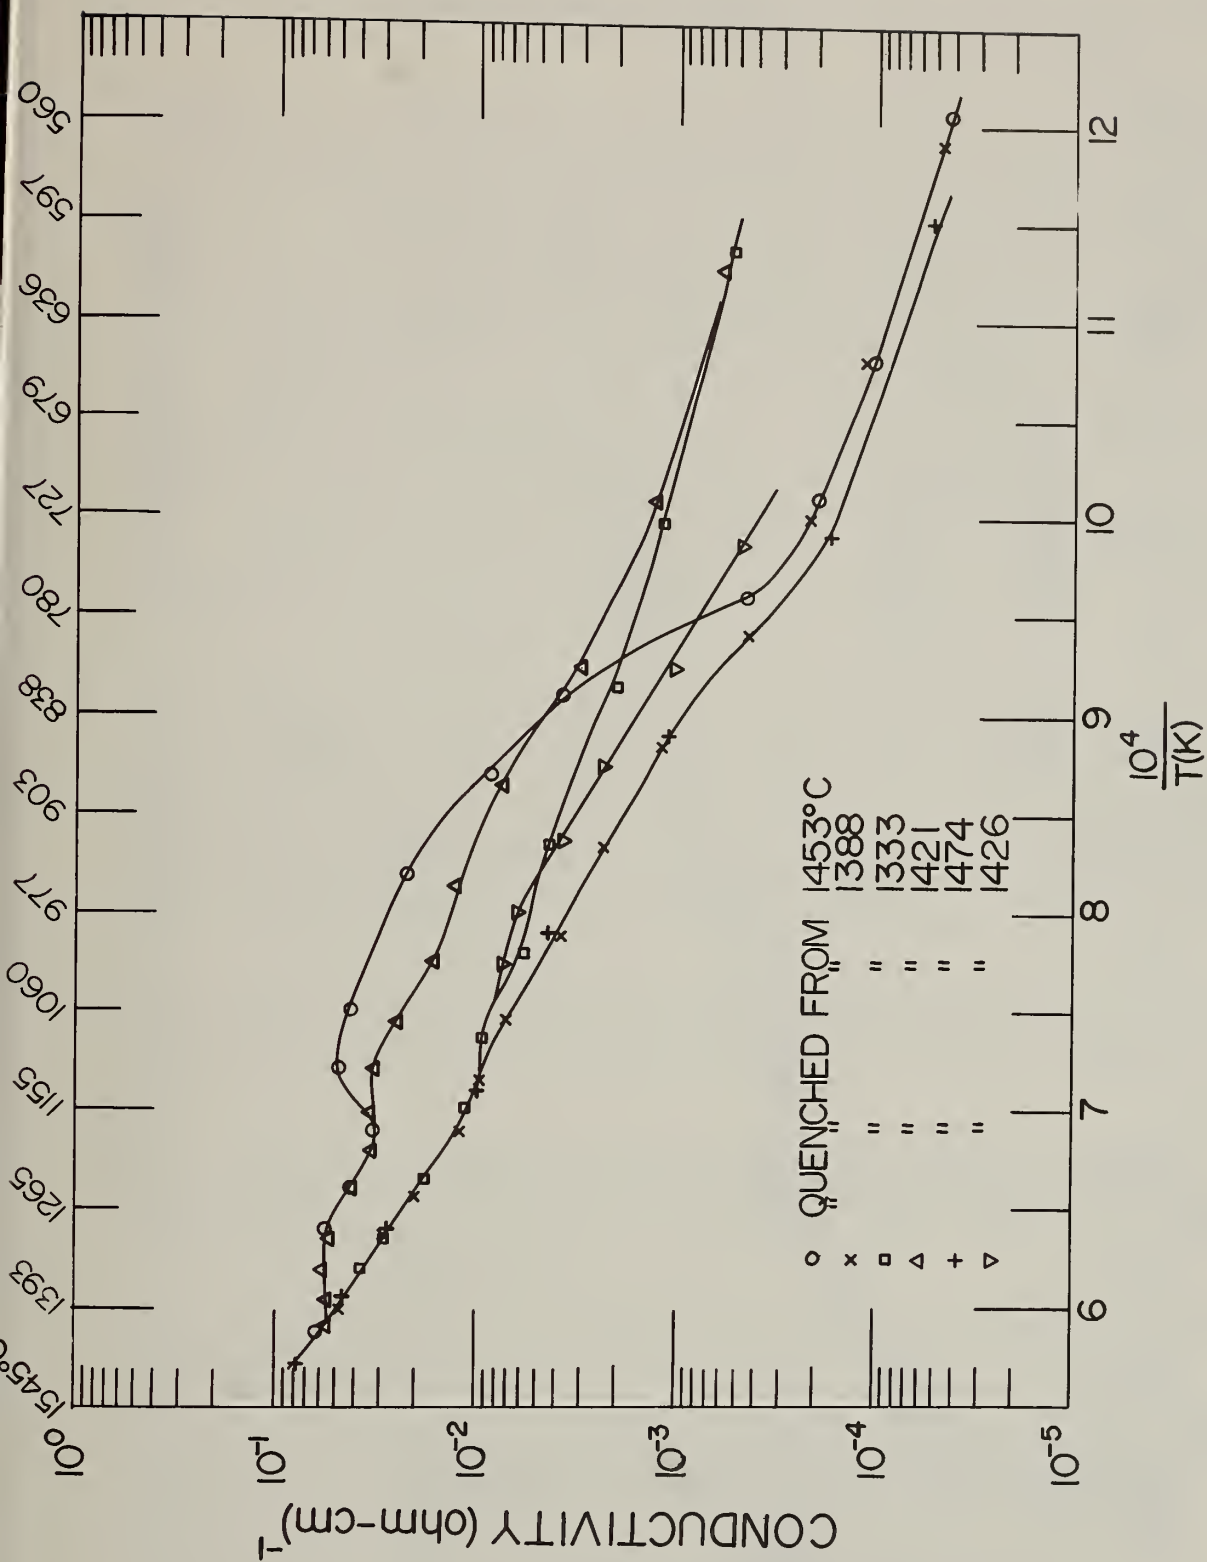
Figure 3. Electrical conductivity of Bow NH slag with 20% K_2SO_4 added to the melt. All data was taken in 2×10^{-6} O_2 atmospheres in N_2 and with increasing temperature after being quenched to 900°C from the equilibration temperatures indicated on the graph.

crystalline phases contributing to the conductivity. In the reduced O_2 pressure experiment, a break in the conductivity curve occurs near $1160^\circ C$ for all data; the break becoming more pronounced for the runs where the sample is quenched to $900^\circ C$ from soak temperatures above $1400^\circ C$. All data shown on the graph is taken with increasing temperature after being quenched to $900^\circ C$ and cooled slowly to the lower temperature ($\sim 500^\circ C$). The data below $800^\circ C$ may be affected by cracks in the slag body formed by quenching to $900^\circ C$ and subsequent cooling to lower temperatures. Cracking appears to be more severe in those samples with the K_2SO_4 added. It would be interesting to see how the coefficients of thermal expansion for these seeded and unseeded slags differ. X-Ray diffraction measurements (courtesy of H. Parker, Center for Materials Science, Solid State Chemistry Group) show that the phase composition below $1180^\circ C$ is a kalsilite like phase (probably $KAlSiO_4$) and spinel (Fe_3O_4) for that material quenched from $1426^\circ C$. This kalsilite like phase was not detected in the slag measured in an air atmosphere and quenched from nearly the same temperature ($1420^\circ C$). The spinel (Fe_3O_4) was detected in the sample measured in air. The interesting and unusual aspect is that the slag conductivities for Bow NH slag with and without seed and measured in air and in an atmosphere of $2 \times 10^{-6} O_2$ partial pressure are the same as a function of temperature above $1400^\circ C$. If the potassium ion conductivity is the predominant mechanism for charge transport, above $1400^\circ C$, the samples containing added K_2SO_4 should have a higher conductivity. Chemical analysis for K and S of the Bow NH slag with 20 wt.% K_2SO_4 added to the melt before and after the electrical measurement (2×10^{-6} atmos O_2) are given in Table 1.

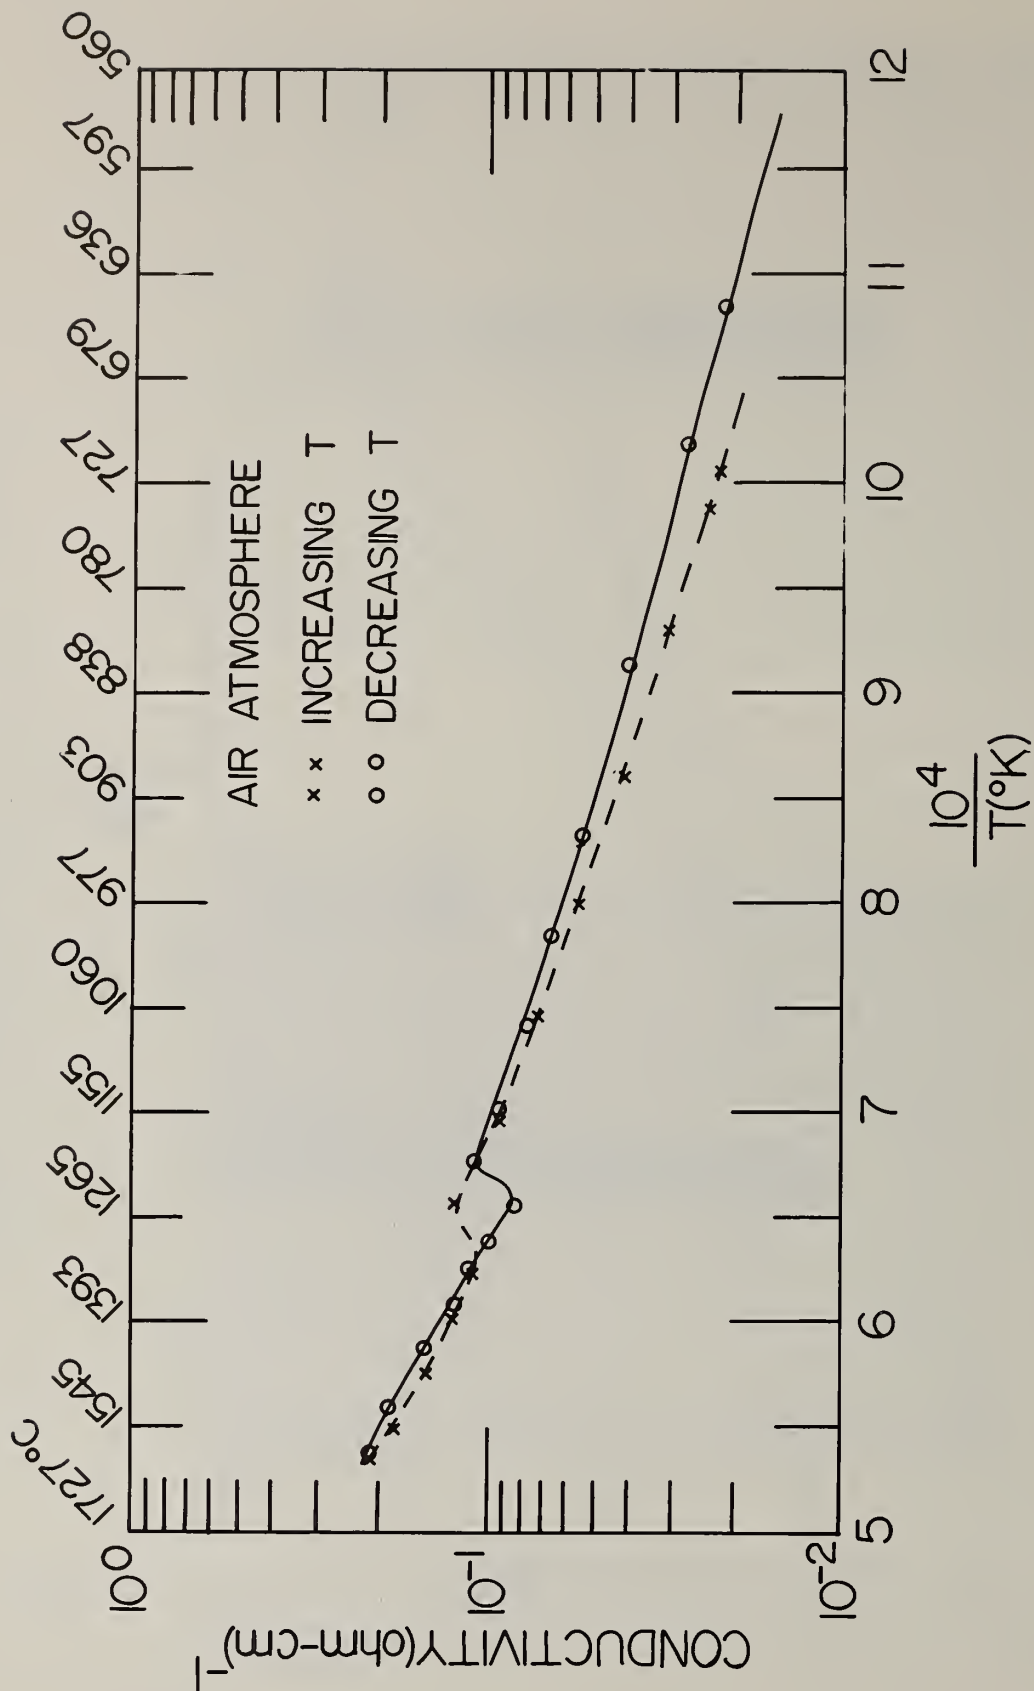
Figure 4. The electrical conductivity of $\text{Sr}_{0.9}\text{La}_{0.1}\text{Zr}_{0.7}\text{Cr}_{0.3}\text{O}_3$ as a function of temperature for increasing and decreasing temperatures.

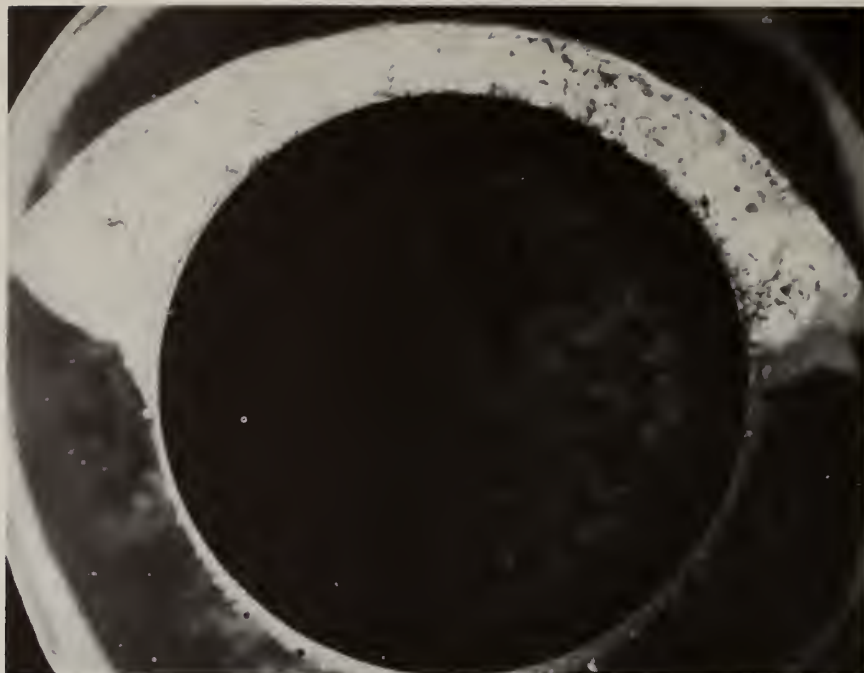
Fig. 1. Section of Type 304 stainless steel tubing after exposure to K_2CO_3/K_2SO_4 seeded oxygen rich hot gas stream. Note formation of thick deposit, 1.7 mm, on upper surface and thin powdery deposit on lower surface. Tube temperature 400°C. 6 X.

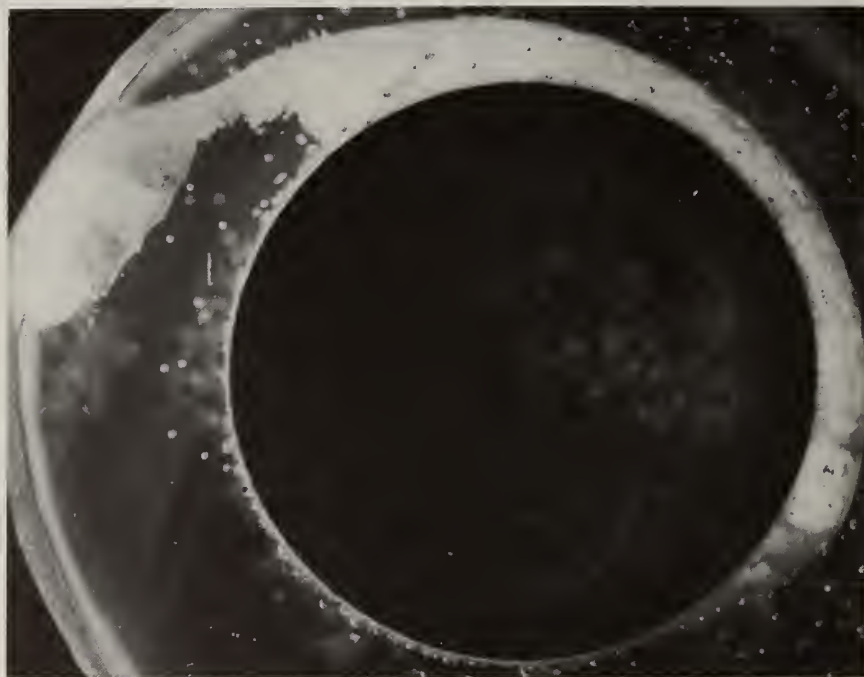
Fig. 2. Section of Type 304 stainless steel tubing after exposure to K_2CO_3/K_2SO_4 seeded oxygen rich hot gas stream. Note formation of thick deposit, 1 mm on upper surface. Tube temperature 500°C. 6 X.

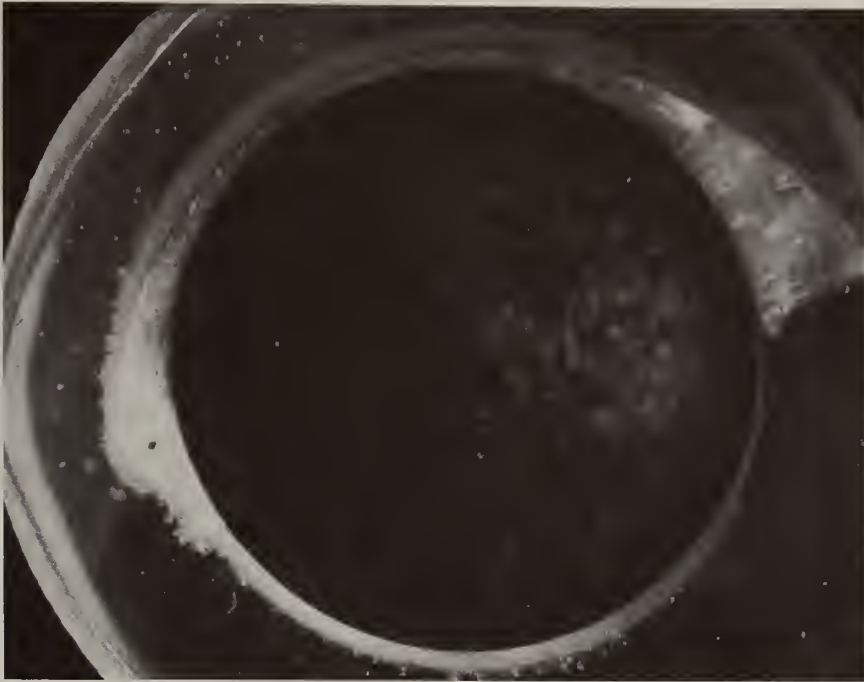
Fig. 3. Section of Type 304 stainless steel tubing after exposure to K_2CO_3/K_2SO_4 seeded oxygen rich hot gas stream. Note formation of thinner deposit on upper surface. Tube temperature 590°C . 6 X.

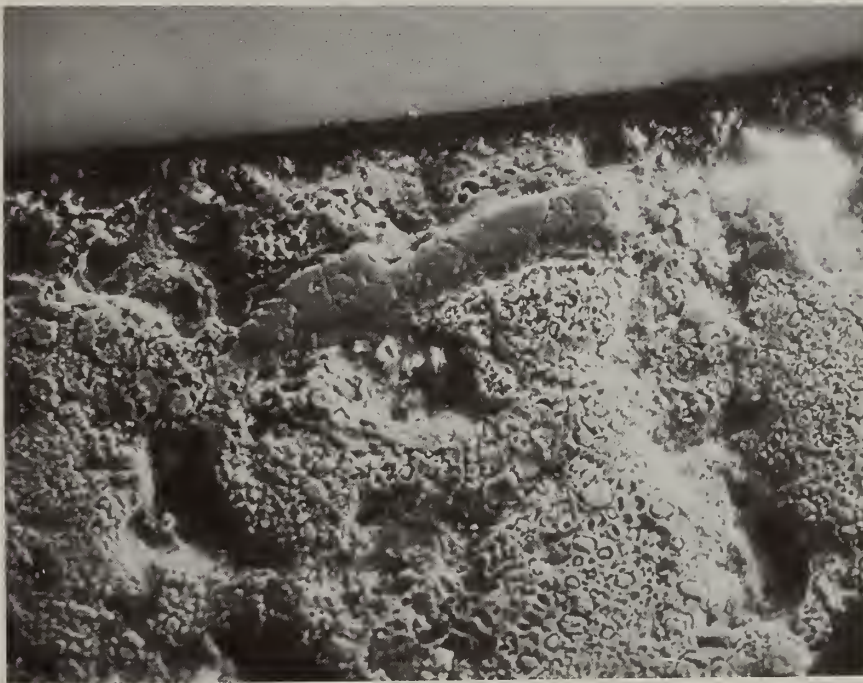
Fig. 4. SEM micrograph, 200 X, of small, high potassium concentration nodes in the salt deposit. Specimen temperature 400°C ; gas stream oxygen rich.

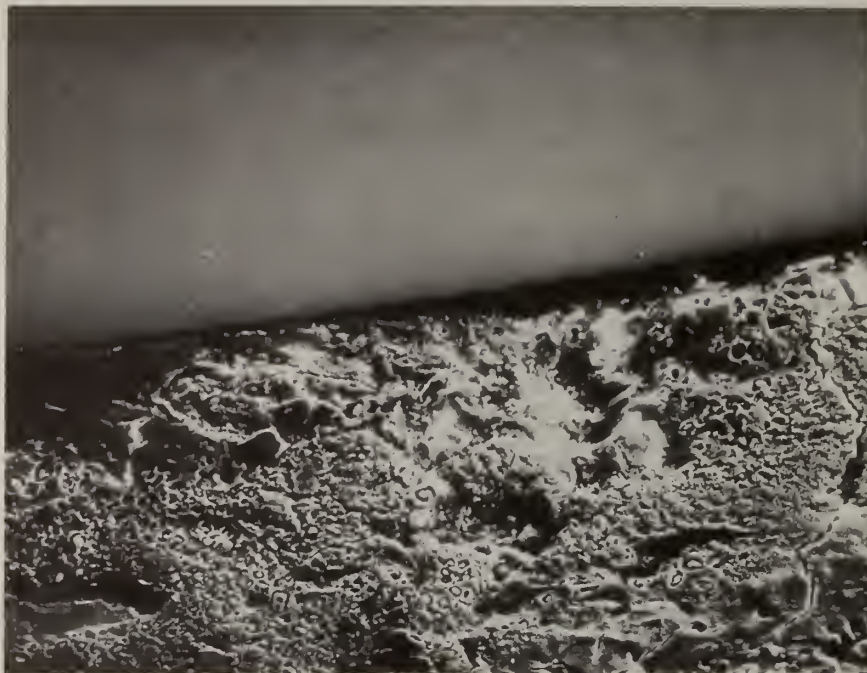
Fig. 5. SEM micrograph, 200 X, of small, high potassium concentration nodes in the salt deposit. Specimen temperature 500°C; gas stream oxygen rich.

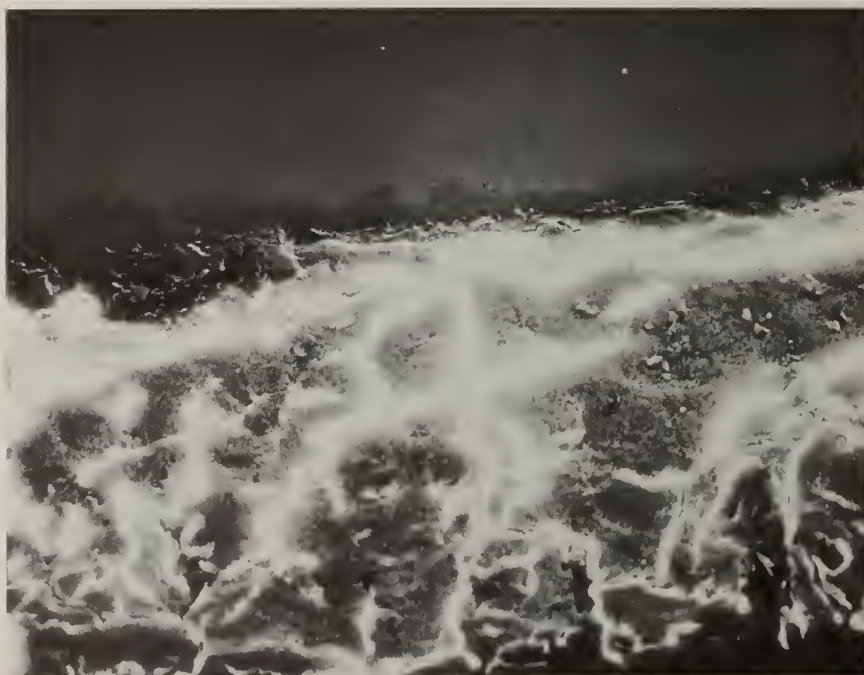
Fig. 6. SEM micrograph, 200 X, of salt deposit showing absence of high potassium concentration nodules. Specimen temperature 590°C; gas stream oxygen rich.

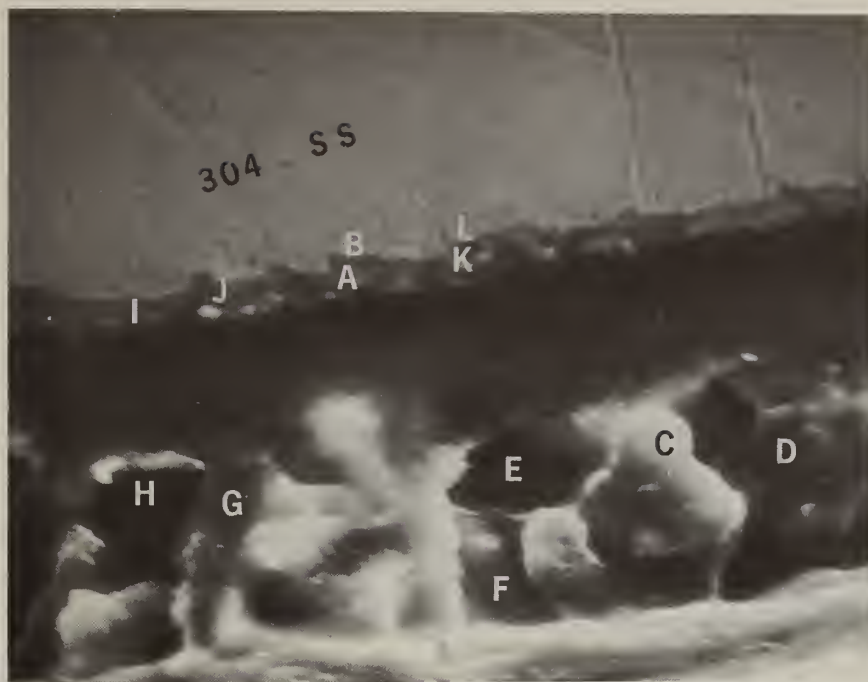
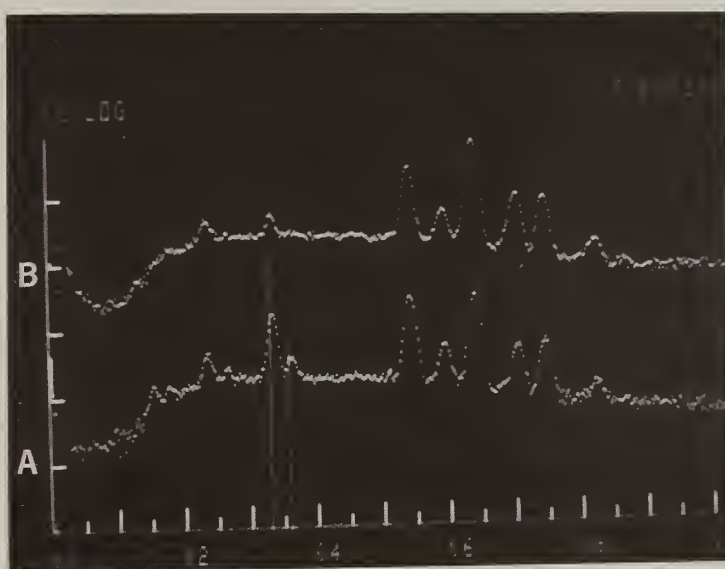
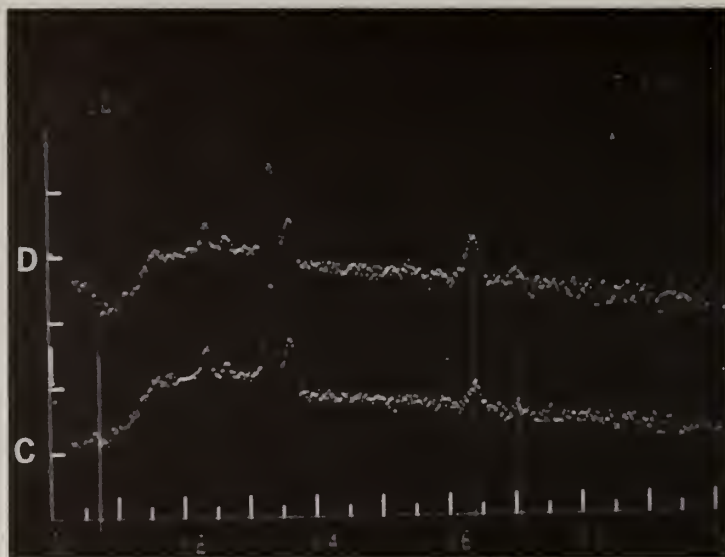
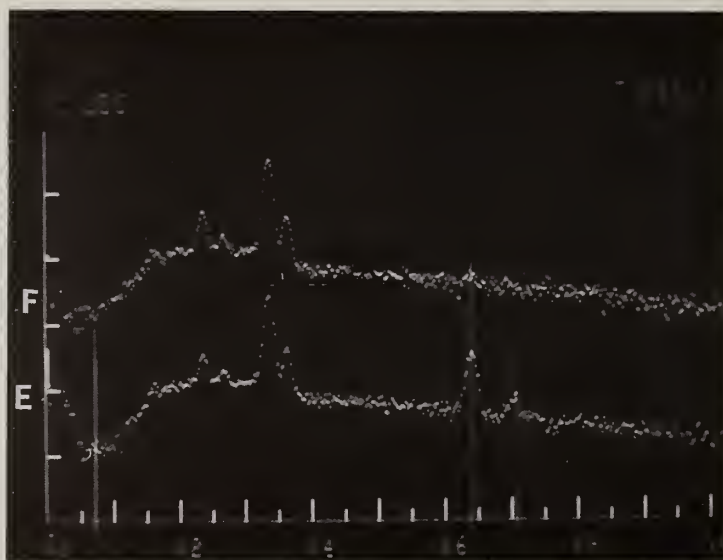
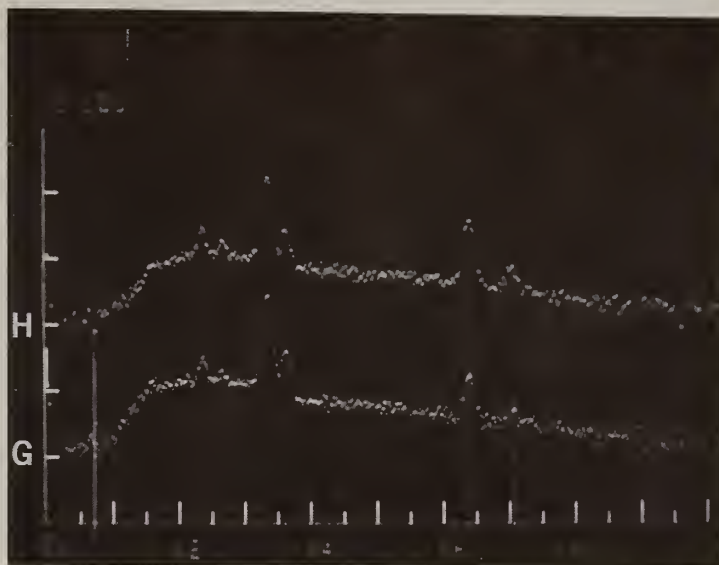
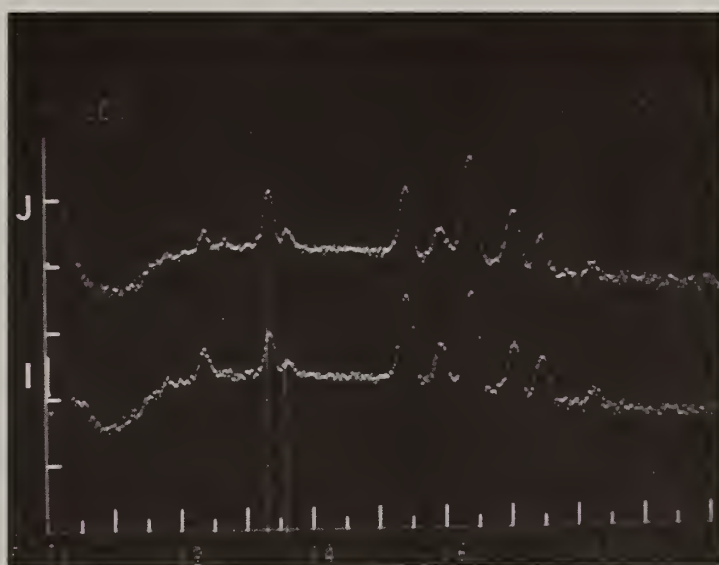
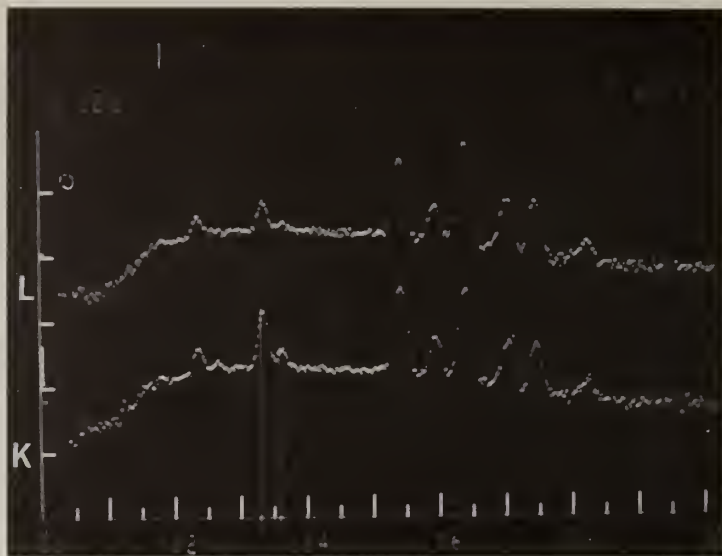
Fig. 7. SEM micrograph, 2000 X, of stainless steel-salt deposit reaction zone. Lettered regions correspond to labeled EDX spectra, figures 7a through 7f. Specimen temperature 500°C; gas stream oxygen rich.

Fig. 7a. EDX spectra of regions A and B of figure 7 showing high Cr concentration area.

Fig. 7b. EDX spectra of regions C and D of Fig. 7 showing region of high potassium concentration associated with Fe in the salt region of the corrosion area.

Fig. 7c. EDX spectra of regions E and F of Fig. 7 showing Fe penetration in the salt.

Fig. 7d. EDX spectra of regions G and H of Fig. 7 showing Fe penetration in the salt.

Fig. 7e. EDX spectra of regions I and J of Fig. 7 showing areas of high Cr and low Ni concentration.

Fig. 7f. EDX spectra of regions K and L of Fig. 7 showing areas of high Cr concentration formed on stainless steel edge.

The corrosion band area on the 304 stainless steel increases with increasing temperature. The variation in corrosion can be observed in the comparison of Figure 7 (specimen temperature 500 °C) with Figure 8) specimen temperature 590 °C). SEM/EDX analysis of both samples, Figures 7a-7g and Figures 8a-8j, indicate metal corrosion and metal cation migration, however, the 590 °C specimen shows the corrosion picture more vividly.
